The Manitoba Border Dike

Manitoba
North Dakota

**Developed by:
The ND State Water Commission**

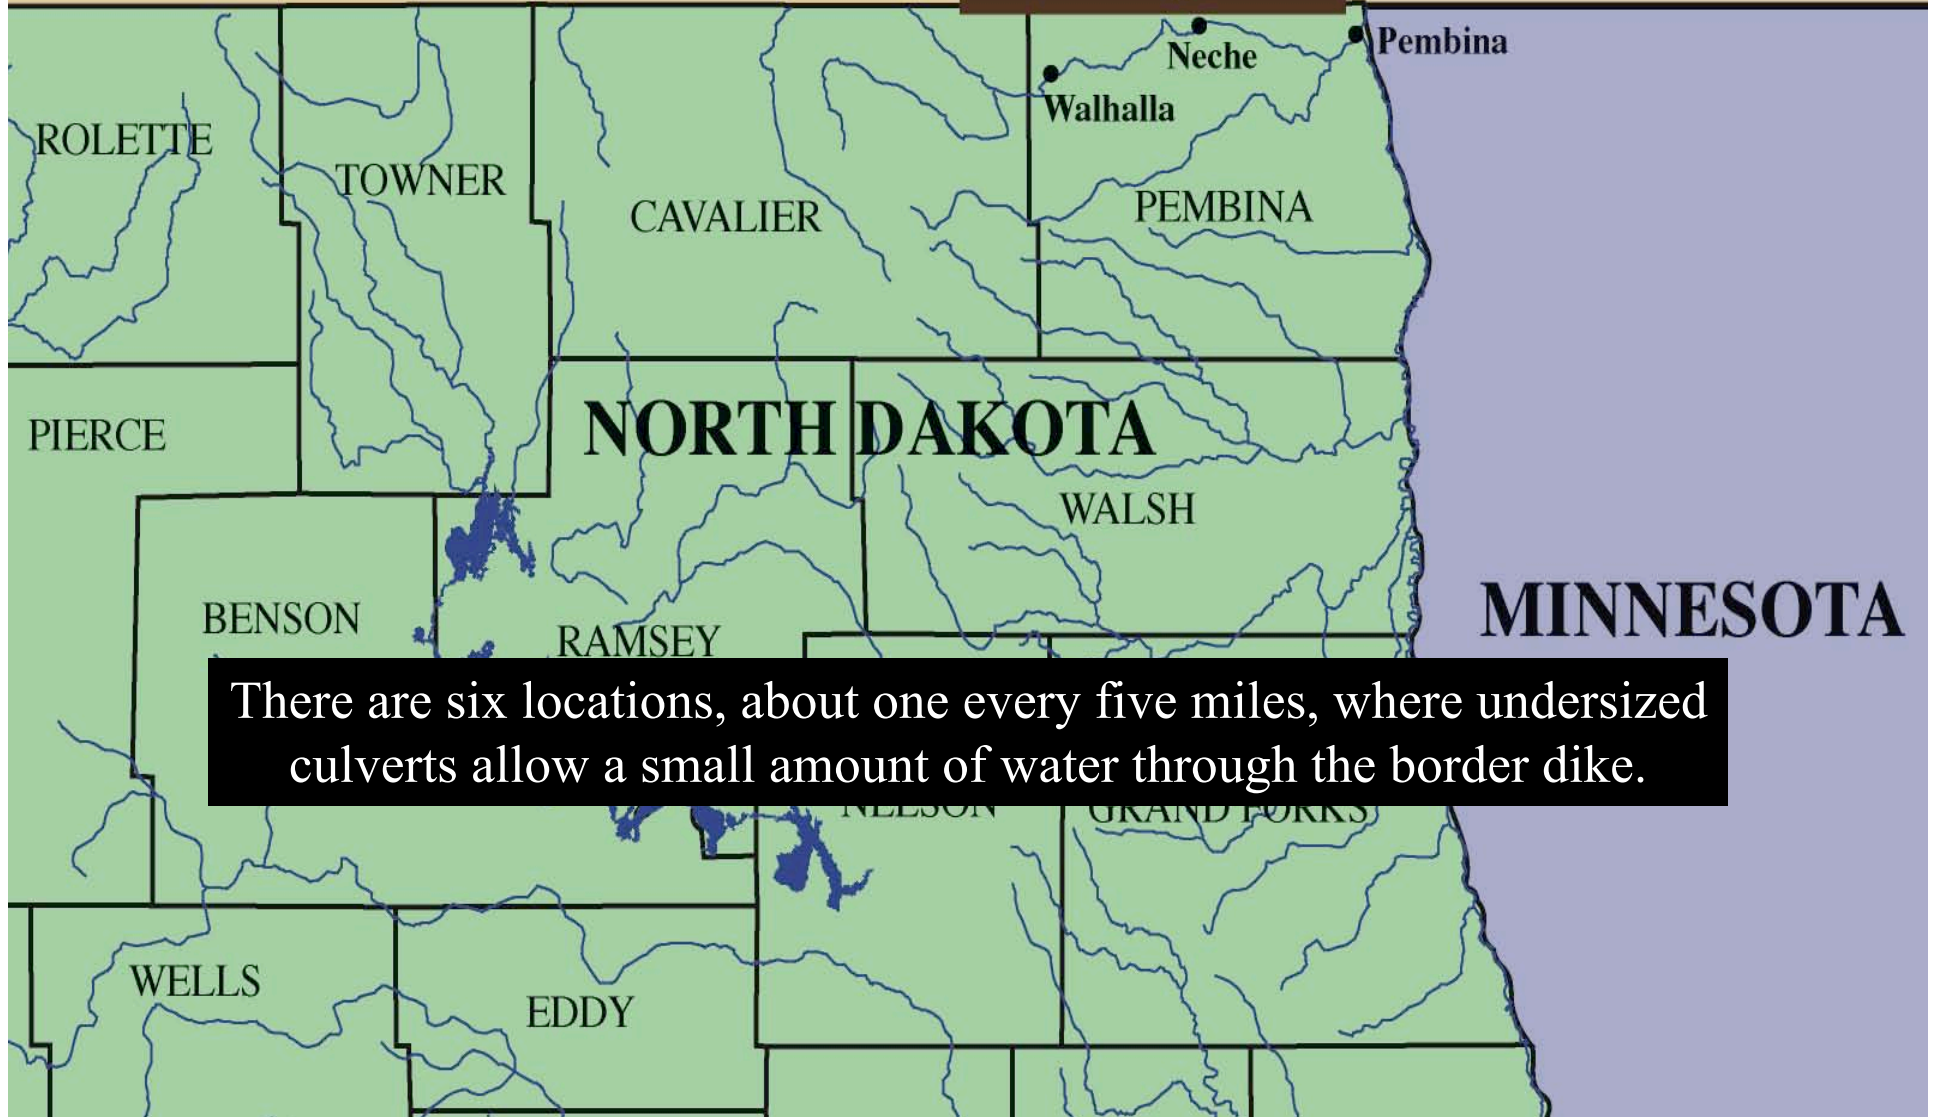
Manitoba Border Dike

In 1946, private residents in Manitoba began building dikes just north of the border. Over the years, the dikes were consolidated into a single structure, extending 30 miles in length.

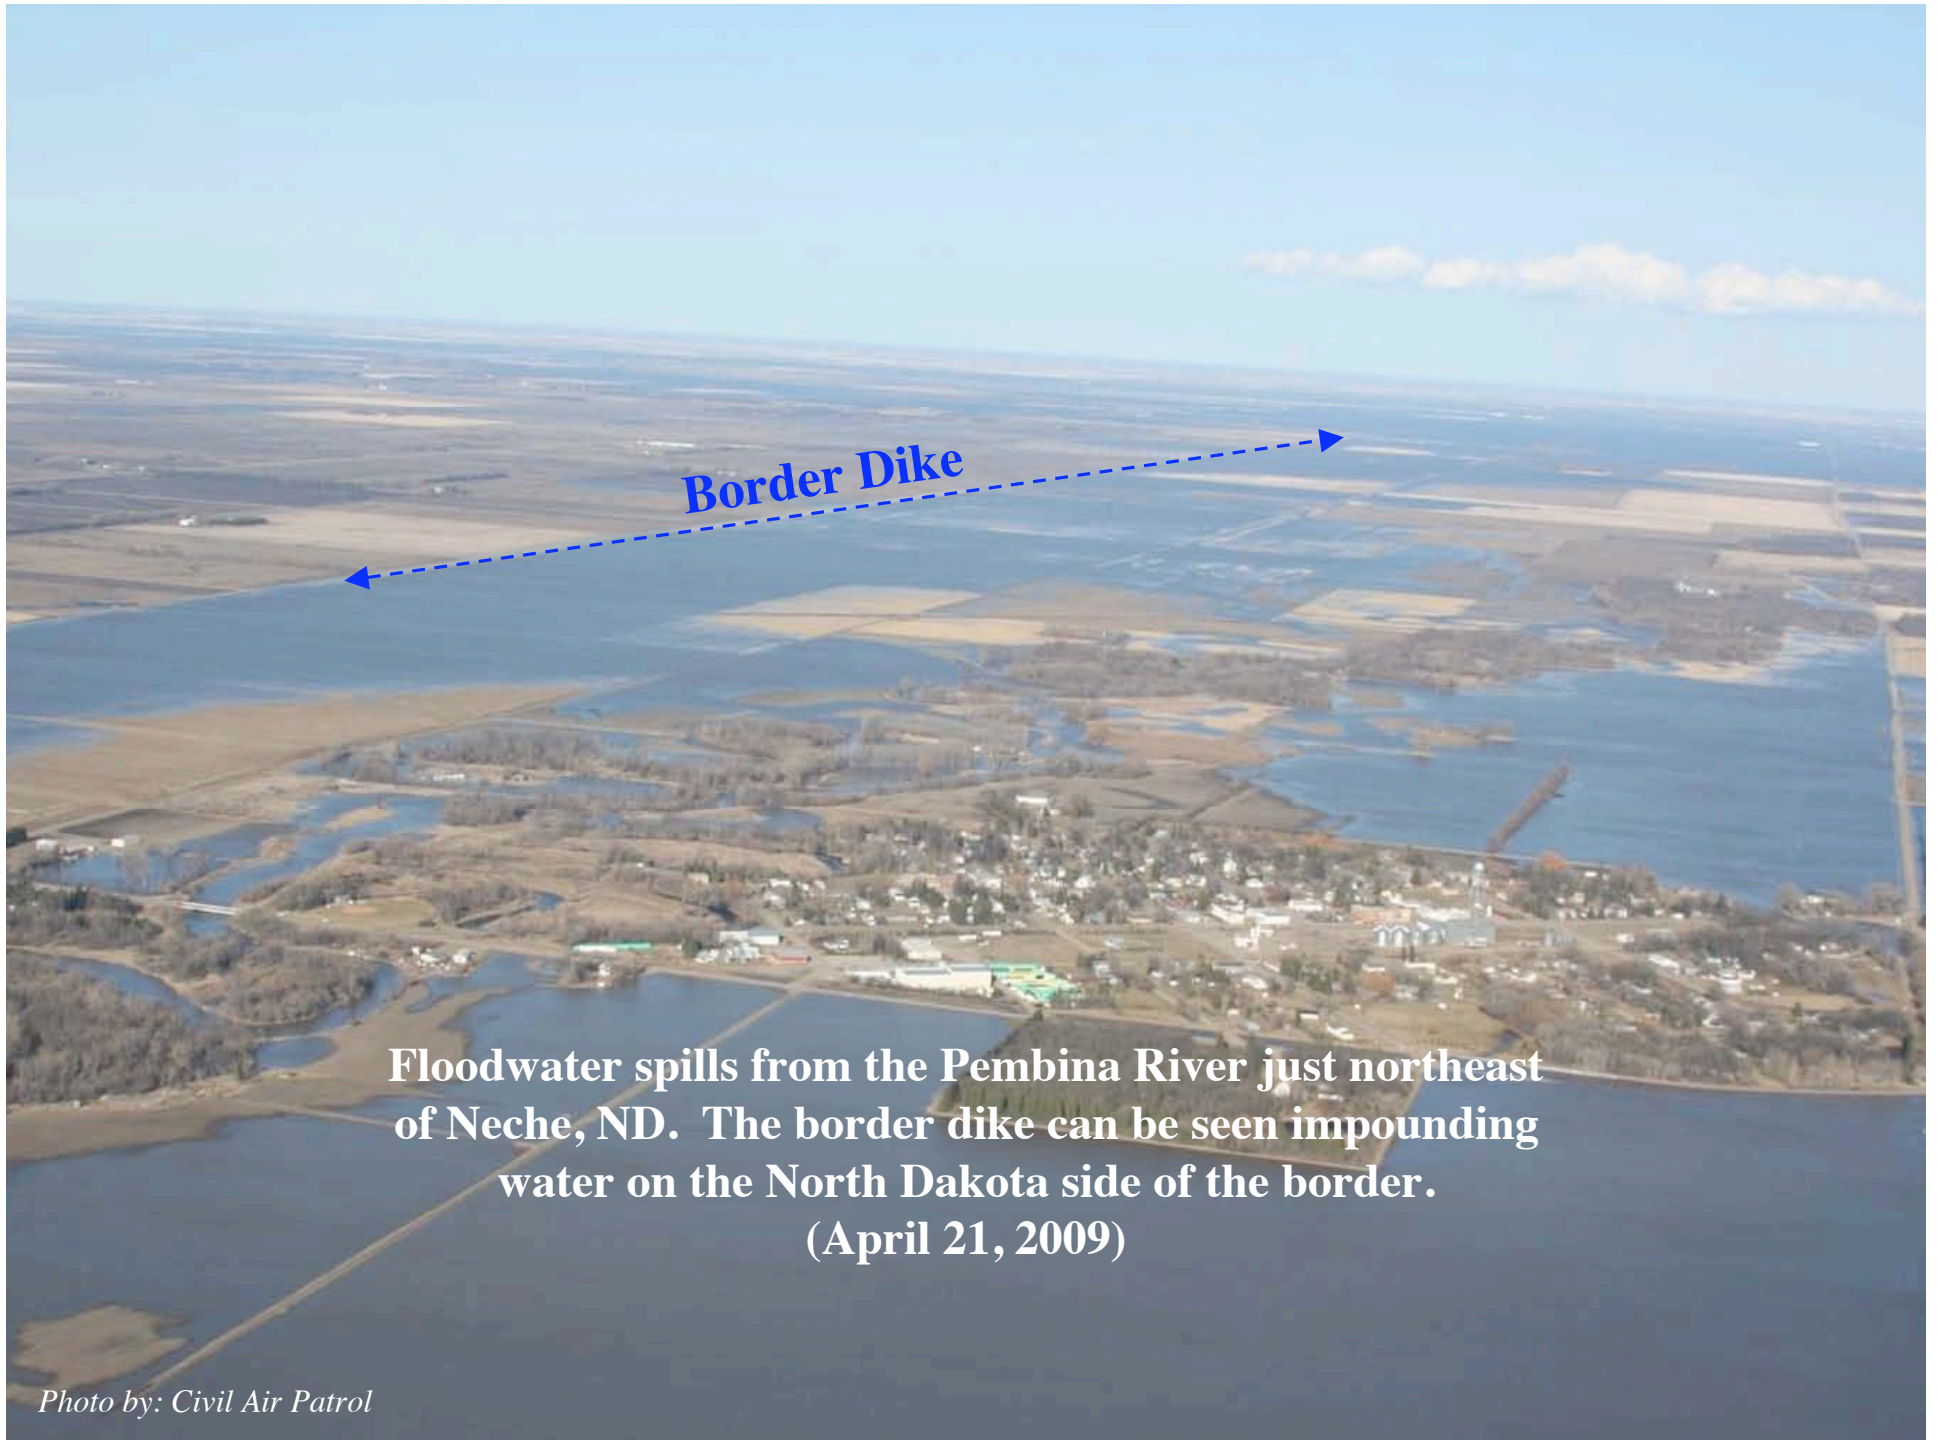
**Floodwater spills from the Pembina River just northeast of Neche, ND. The border dike can be seen impounding water on the North Dakota side of the border.
(April 21, 2009)**

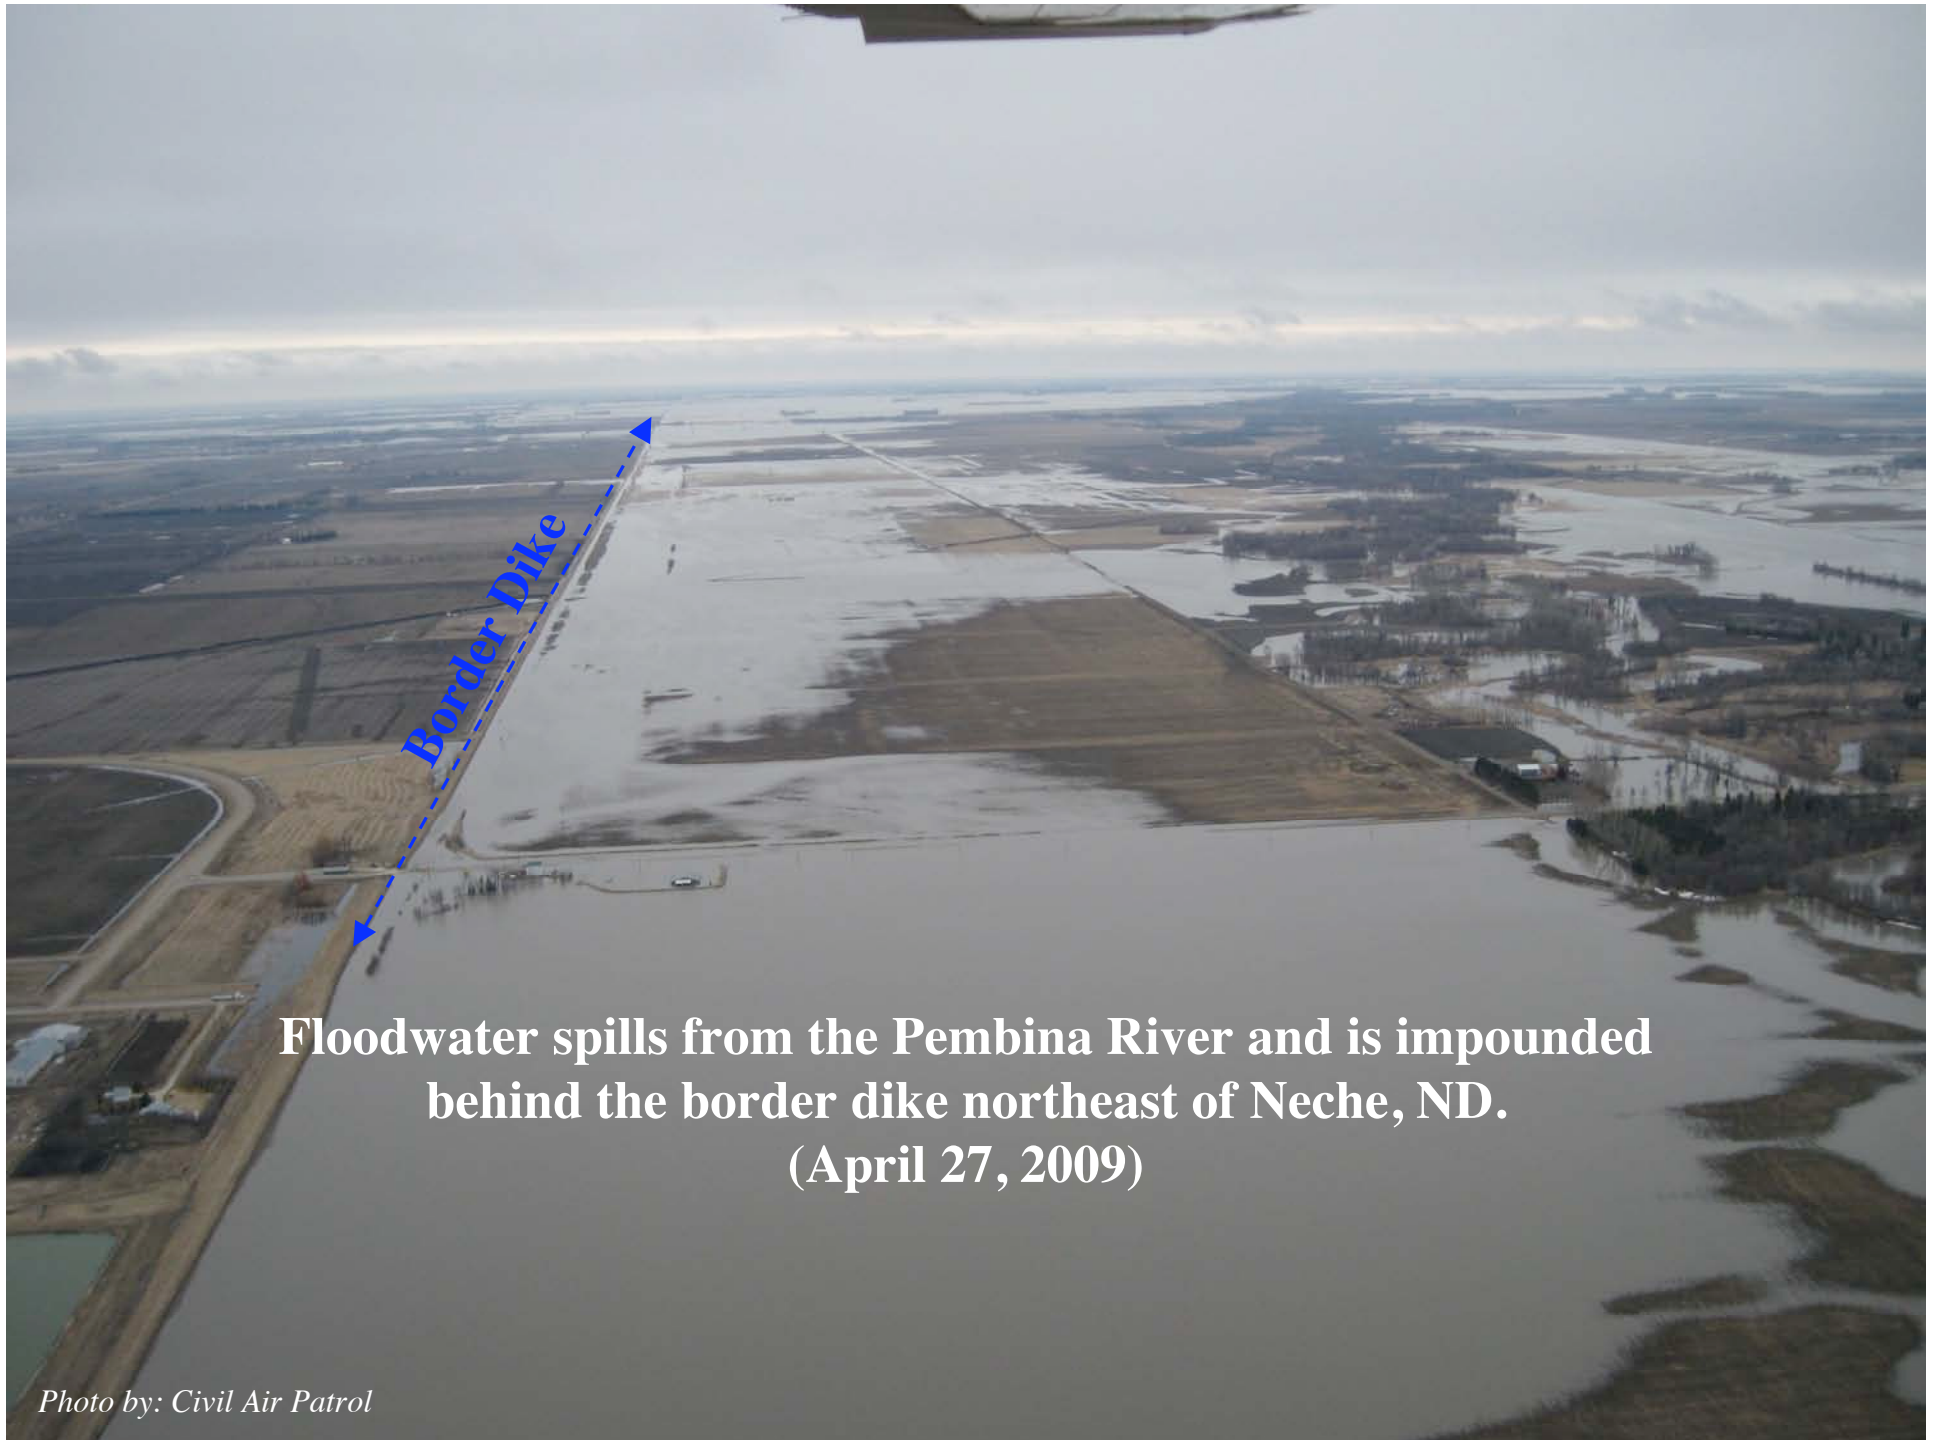
**Floodwater spills from the Pembina River and is impounded
behind the border dike northeast of Necho, ND.
(April 27, 2009)**

After decades of frustration and millions of dollars in crop losses and damages to infrastructure, the natural water courses need to be restored.
